Safety bulletin provided with permission from: Gil's Garage

Gil Baumgartner

1957 Reproduction Air Cleaner Assembly, Potential Problem

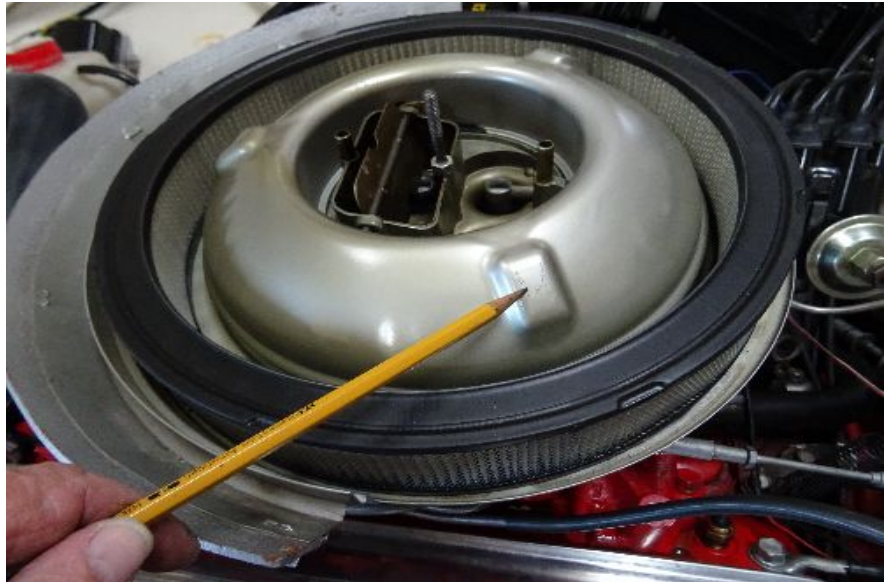
Photo # 1 shows an original 1957 air cleaner base. The purpose of the three raised areas in the lower dome is to prevent the chrome plated top cover from being sucked down during acceleration. Some of the reproduction air cleaners do not have these raised areas, which allow the chrome cover to shut off or restrict air supply during other than normal acceleration such as on ramp or passing acceleration. This has happened a few times with one of our club members. The vehicle continued to accelerate; the engine had to be shut down by turning the ignition key off. The volume of air

required by the carburetor for acceleration caused the throttle plates to stick open and the car would not de-accelerate until the ignition was shut off. The cause for this condition was discovered by Bill Mann a very experienced Thunderbird mechanic, CTCI and Santa Clara Valley Thunderbird Club member.
